AFSWC-TDR-62-137

USAF SHIELDED CAB VEHICLES
TEST AND EVALUATION

TECHNICAL DOCUMENTARY REPORT NUMBER AFSWC-TDR-62-137
February 1963

Development Directorate
AIR FORCE SPECIAL WEAPONS CENTER
Air Force Systems Command
Kirtland Air Force Base
New Mexico

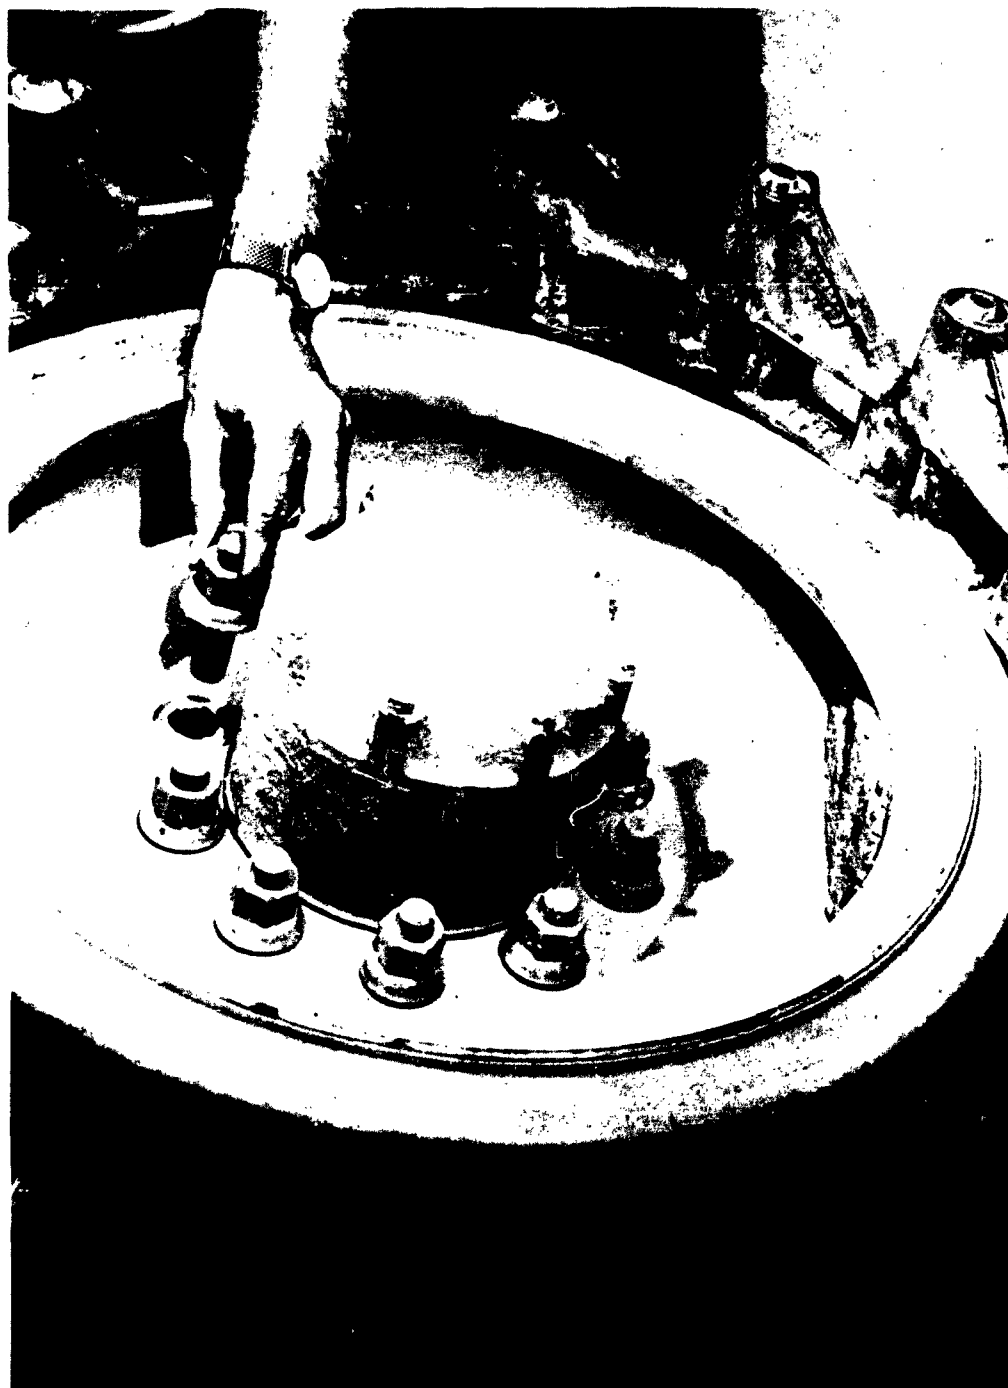
Figure 14. Stud out of rear road wheel

Near the end of the evaluation program, it was noted that the studs in both rear wheels were coming loose from the hub (figure 14). This is due to the excessive weight carried by the rear wheels. To correct for this, the studs were screwed back into the hub and spot-welded in place.

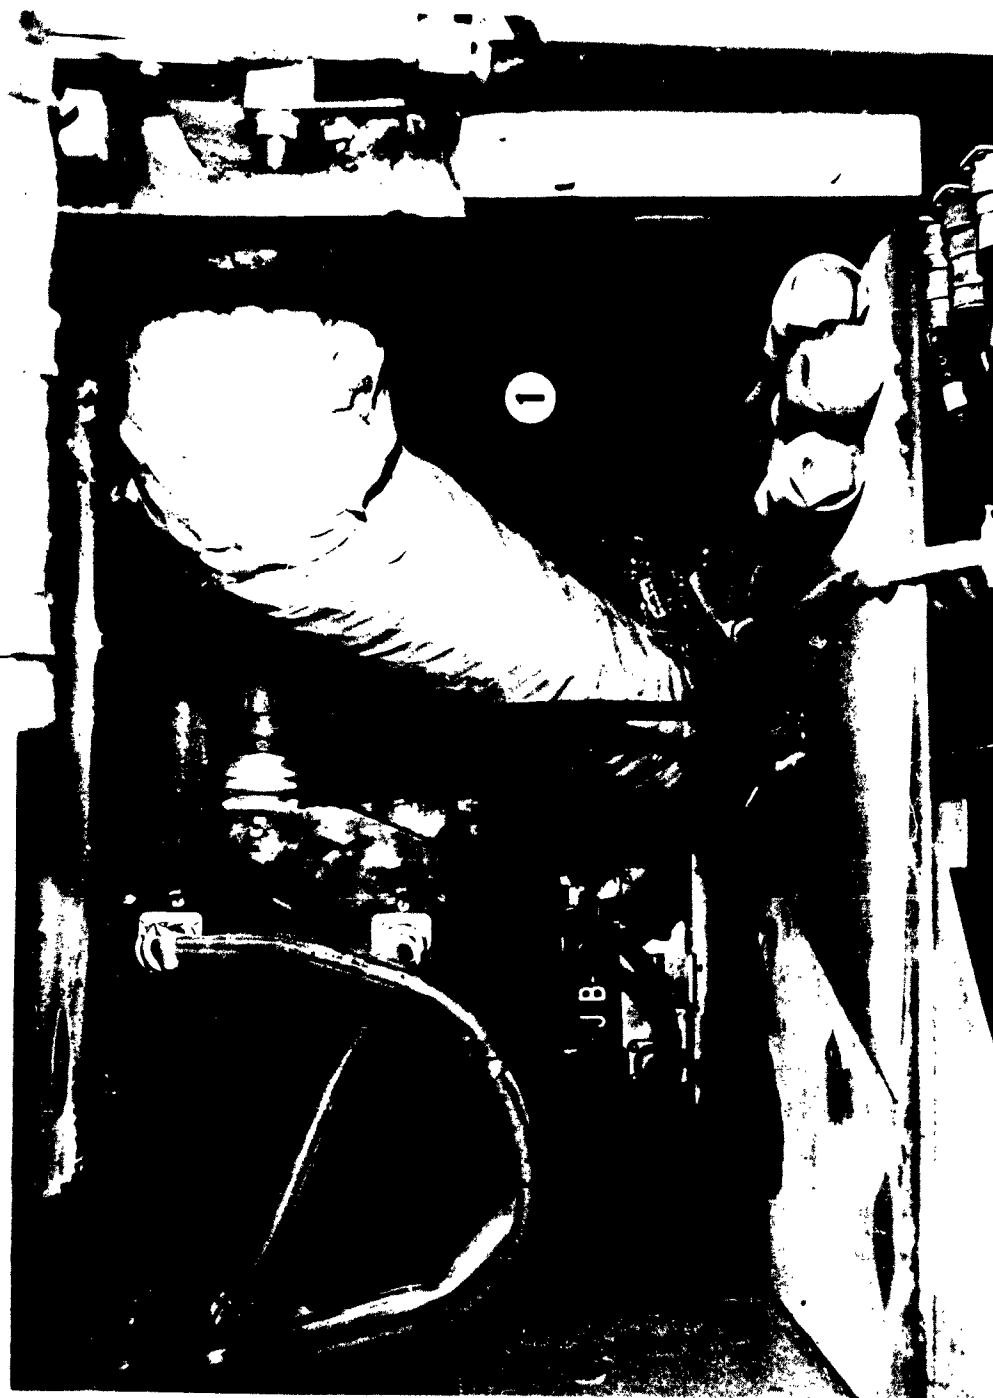
Figure 17. Ducting from air conditioner to cab inlet

In going from the air conditioner outlet to the cab inlet the air had to pass through corrugated rubber ducting to the exterior of the cab where it passes through a helical passageway to the cab interior inlet. The ducting was black and had no insulation. Tests showed that a 20°F temperature rise occurred between blower exit and interior cab inlet. Also, it can be assumed that some head loss existed because of friction from the corrugated surface. The passage for recirculating air back to the air conditioner from the cab outlet also contained the corrugated rubber ducting. Accordingly, the corrugated ducting was replaced with insulated aluminum tubing as shown in figure 17.

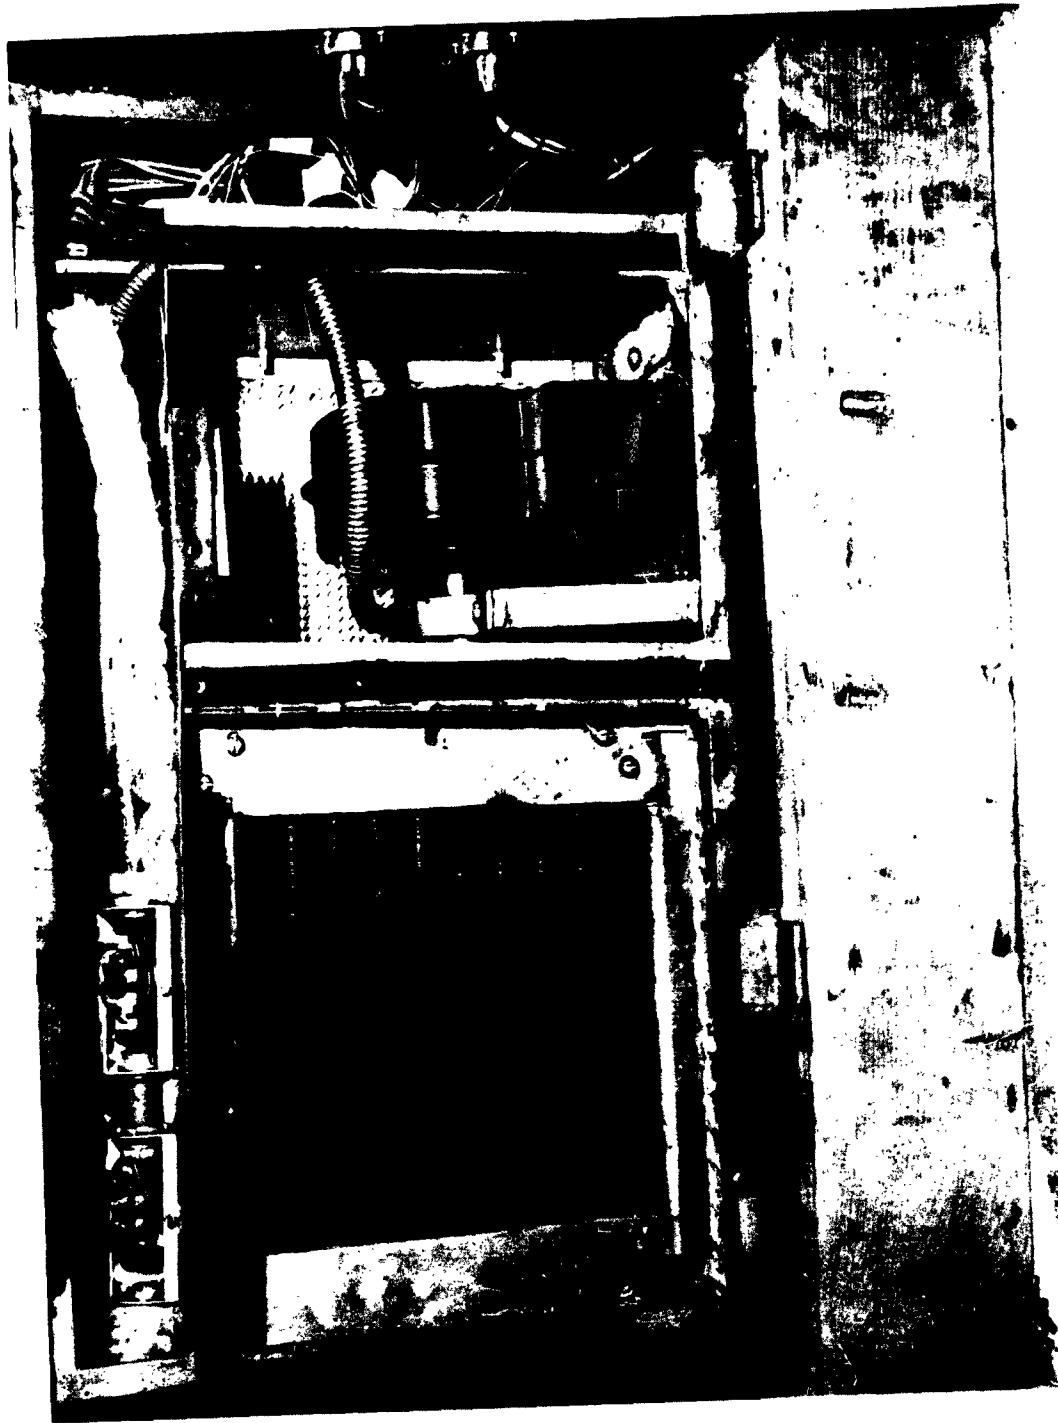
Figure 19. Side view of Beetle air conditioner

Figure 19 shows the air conditioning unit with the side panel pulled away. The blower compartment did not have an air-tight seal and thus allowed ambient air to be mixed in with the cooler air. This not only lowered the efficiency of the unit but it constituted a dust leak. (Figure 20). The seal was improved.

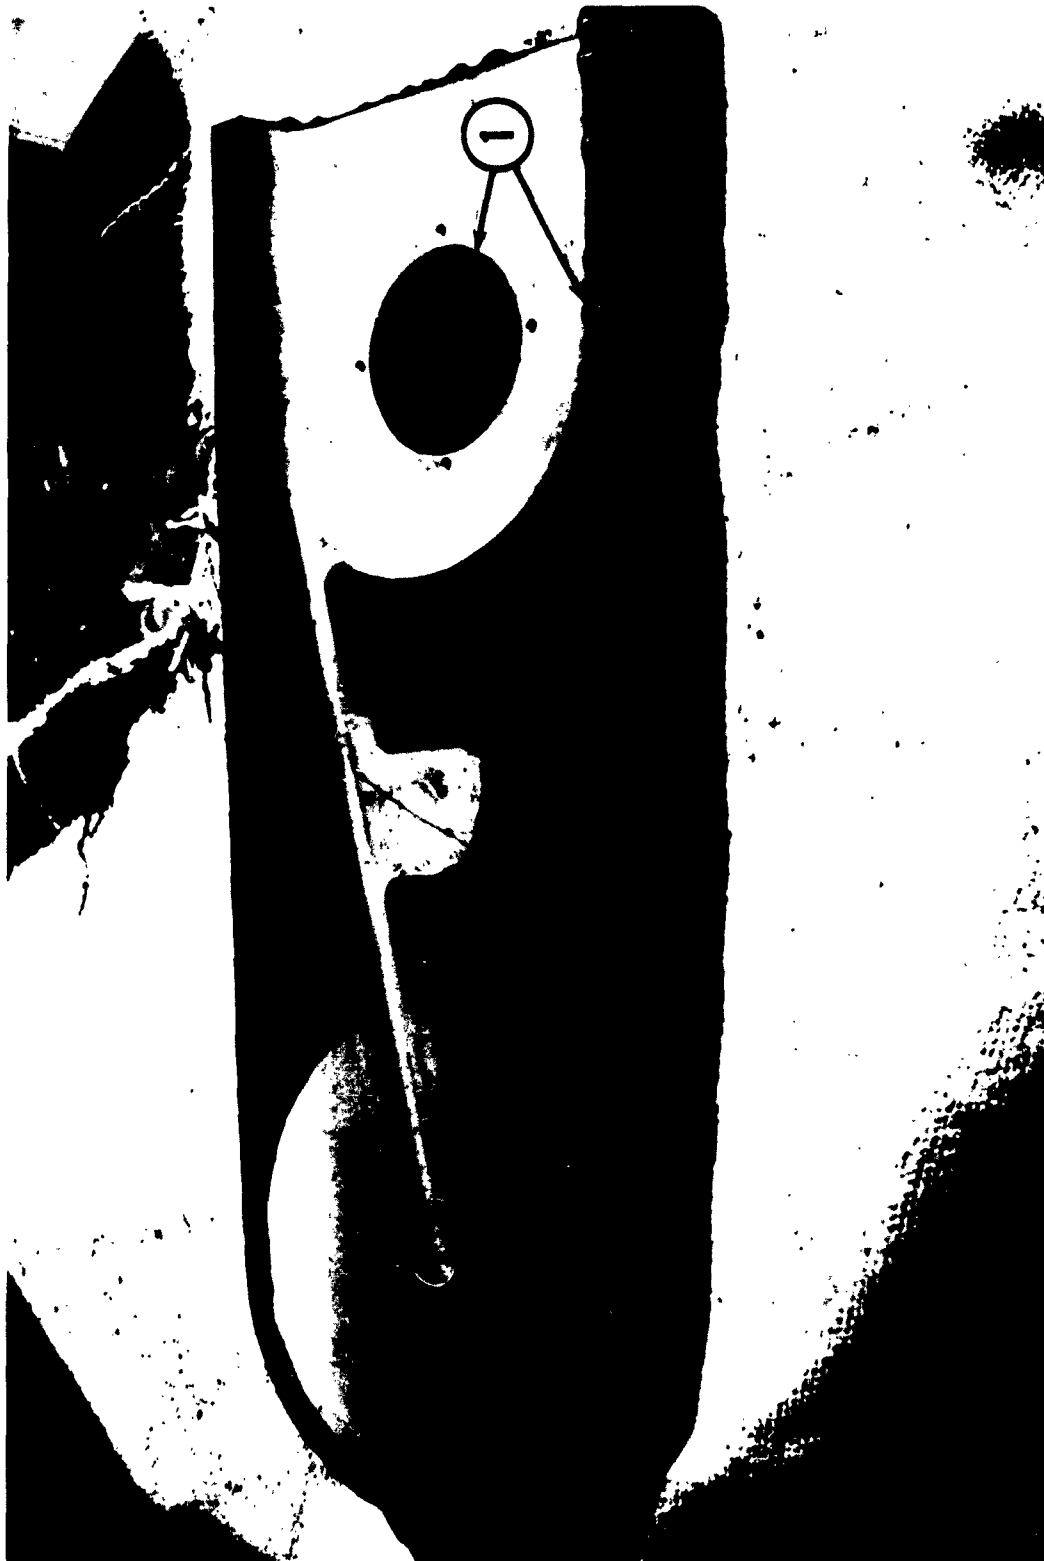
Figure 43. Effect of lubricating oil on neoprene gasket of right manipulator cover plate. 1. Deterioration

With the axis of the wrist joint horizontal, a 100-pound load was applied to the manipulator hand to determine if the slip clutch was holding as rated. It was found that the slip clutch would not hold 100 pounds. Removal of the cover plate and tightening of the slip clutch remedied this problem. Since the manipulator will carry 100 pounds at full cantilever, it can be shown that the manipulator is capable of handling its rated loads for

each joint. It was observed that the gasket on the cover plate was severely deteriorated (see figure 43). This deterioration is due to the effect of the lubricating oil on the neoprene gasket. General Mills Corporation is working on a more suitable gasket material to replace the present gasket.
